Avalanche accident on Erikaksla, Lyngen 30th of March 2022

Accident report

Published 16th of Febuary 2023 on Varsom.no

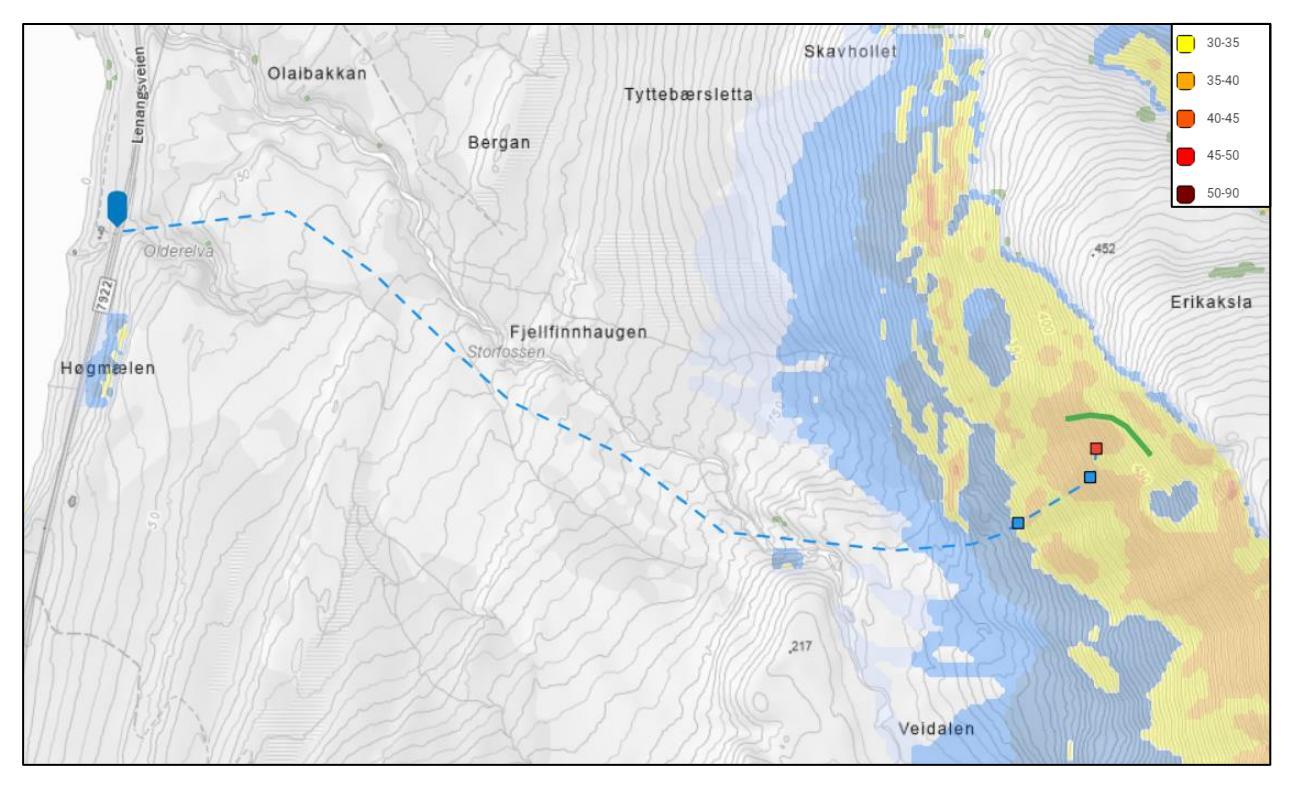
Figure 1 – Track and important points for the group the day of the accident. The blue marker is the starting point of the trip, the blue line is the route followed, the blue squares is the location of the snow pits dug, the red square is the release point, and the green line is the crown of the avalanche. The slope angle colour is found in the top right corner, and the blue areas are runoutsones. All points and lines in this map are approximate positions and based on the memory and description of the event provided by the involved.

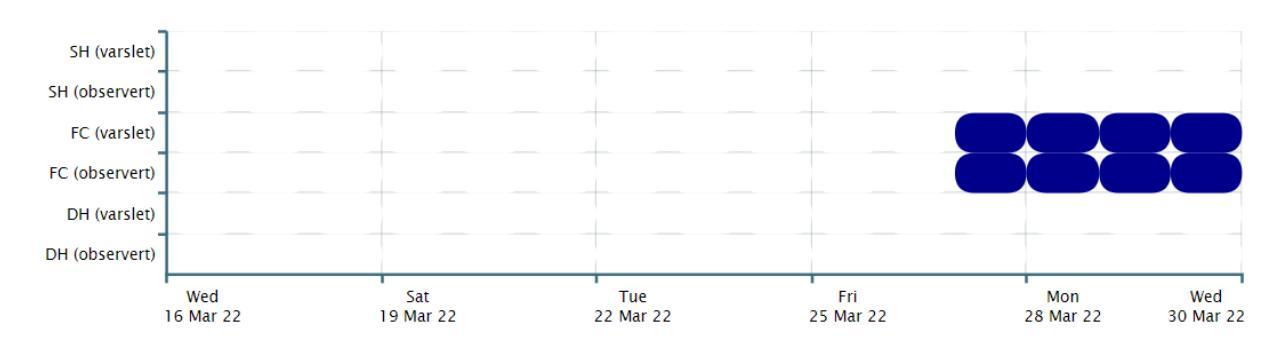
Figure 3 - A figure showing how faceted crystals (FC) had been observed and included in the bulletin (as persistent weak layer) three days prior to the accident.

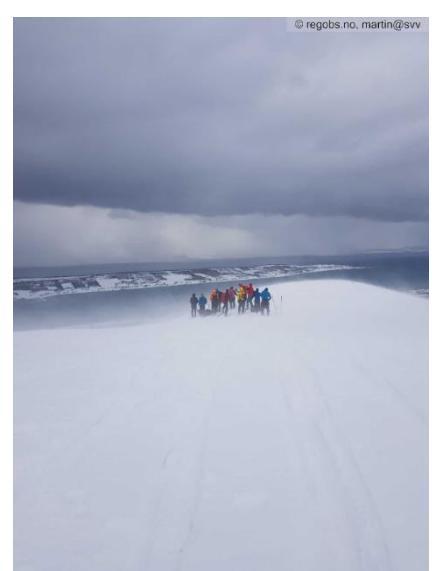
Picture 1 – A group of avalanche forecasters and observers on the ridge of Erikaksla on the 29th of March and experienced heavy winds and snowdrift from north-east. Photo by Martin Venås/SVV (https://www.regobs.no/Registration/298245)

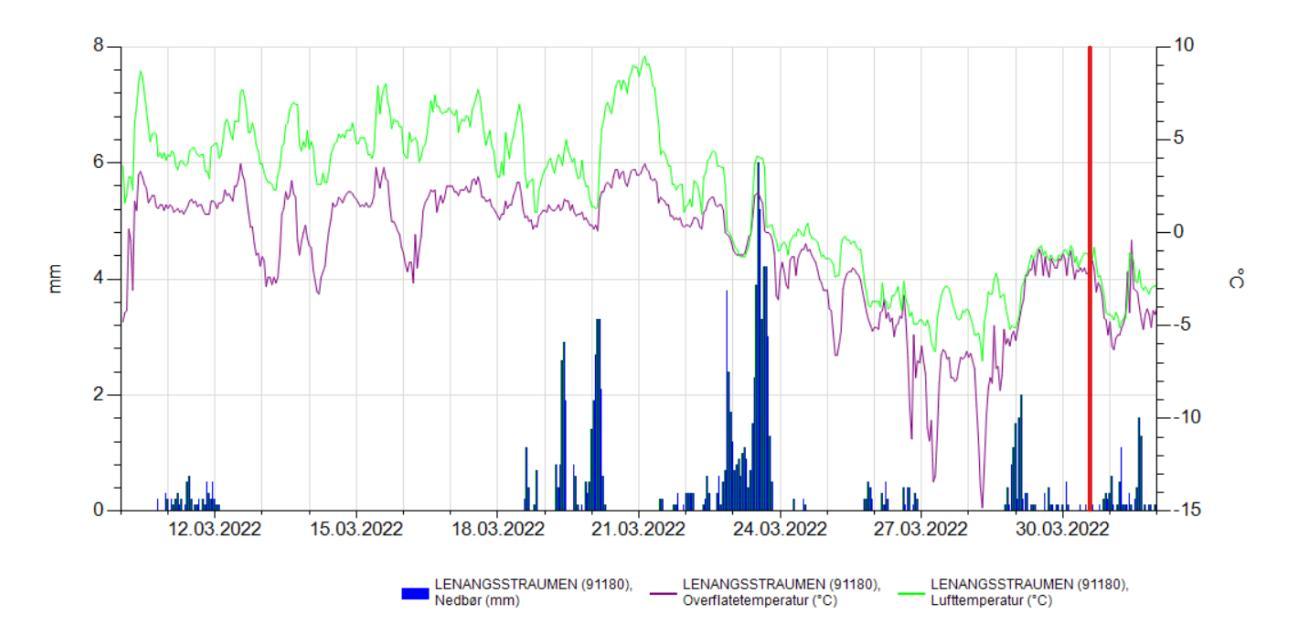
During the night to the 28th and 29th of March the surface temperature dropped significantly below air temperature (Figure 4). This is a result of clear skies and high outbound radiation from the ground. The warmer, moist snow from the 23rd and 24th was buried under cold, new snow from the 26th and the 27th. When the surface temperature dropped the nights before the accident the temperature gradient between the warmer and colder snow was large and this resulted in fast forming facets high in the snowpack.

Figure 4 - The air temperature (green" line), surface temperature (purple line) and precipitation (blue columns) for 10-31 March 2022. Data from a weather station 15 km away from the accident site. The red line marks the time of the accident.

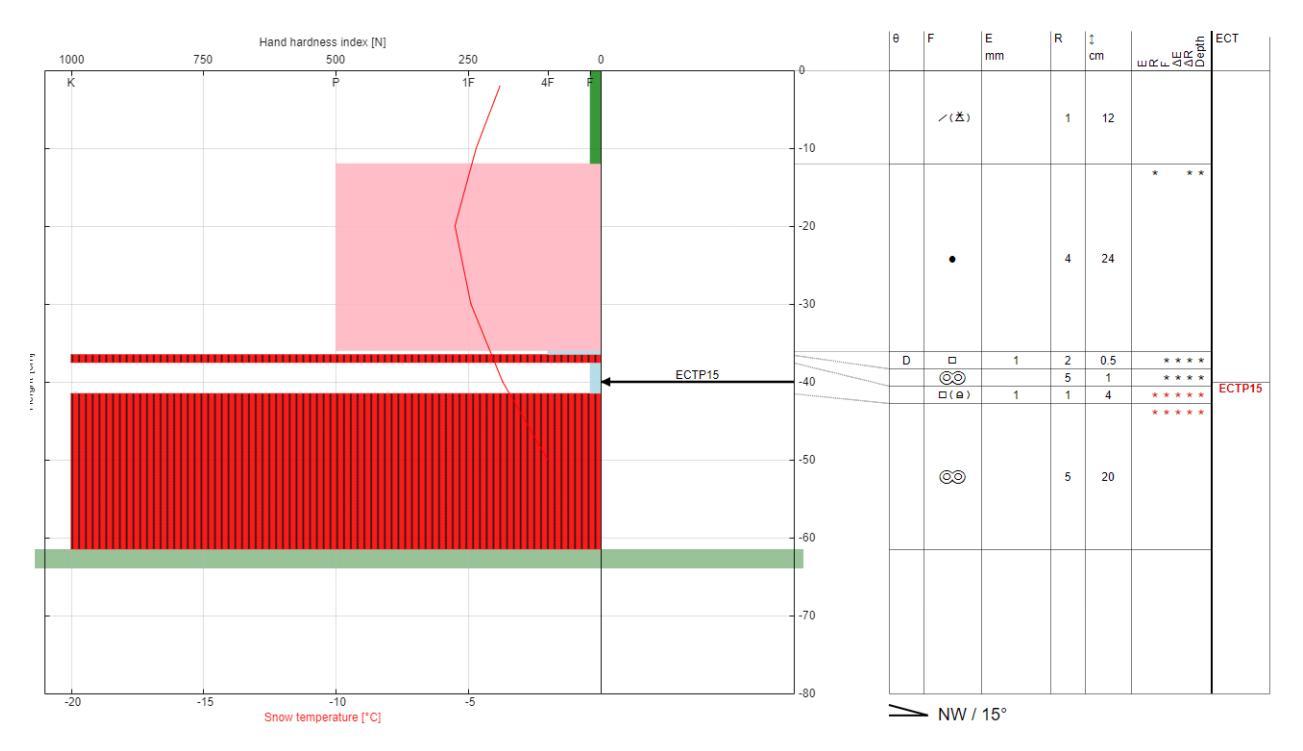
The team of forecasters and observers on Erikaksla dug snow pits in west and northwest-facing slopes. They found a layer of facets developing in the new snow from the evening of the 22nd of March. The weak layer was moistened and compromised by the warming weather on the 23rd of March. The weak layer developed quickly and had different characteristics over short distances on the 29th of March. These observations were done about 1.2 km away from the accident site.

Figure 5 - A snow pit dug in a northwest facing slope, at 233 meters above sea level and 1.2 km away from the accident site on the 29th of March.

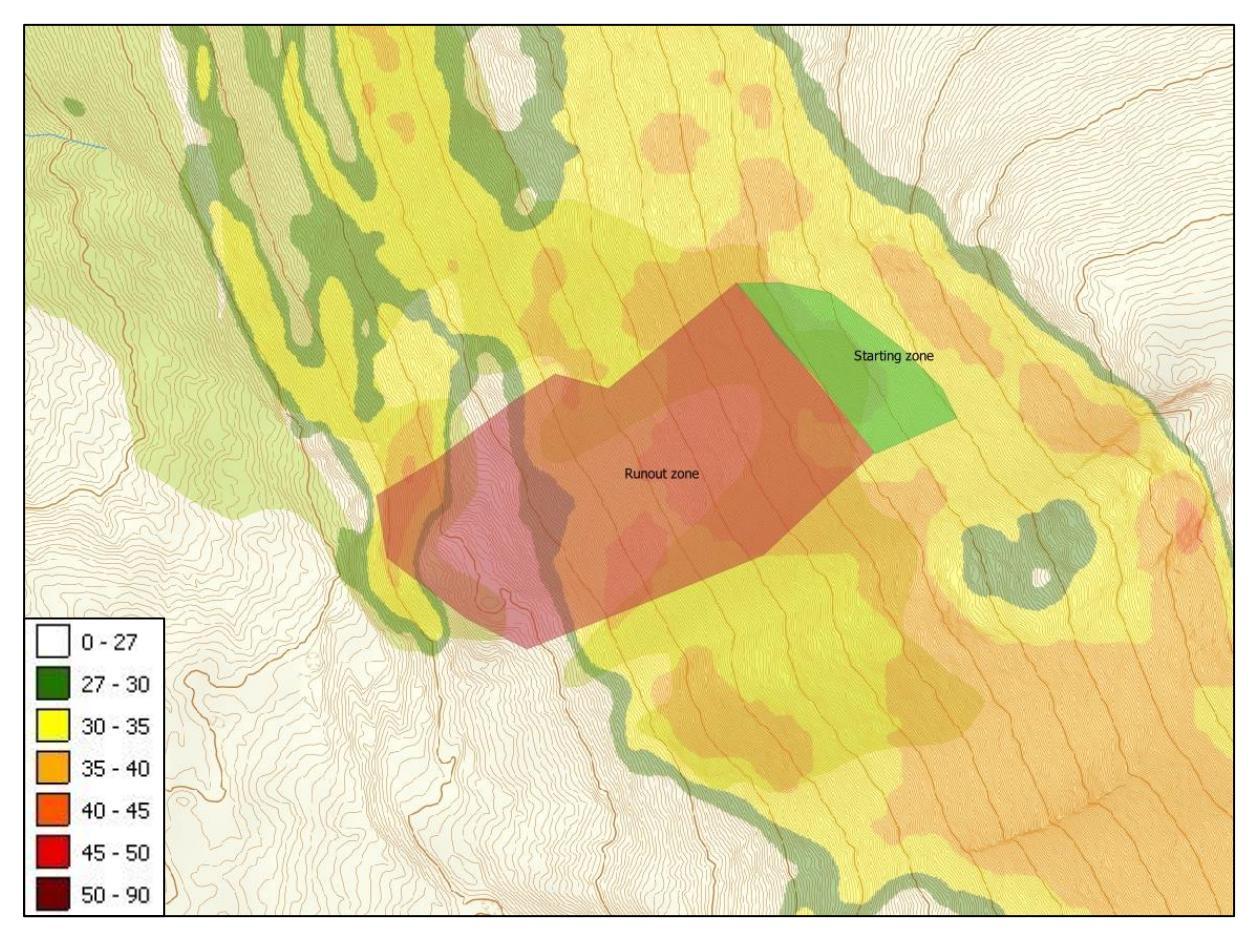
The avalanche was a dry slab avalanche of size 3 – large. The crown was between 20 to 50 cm thick and about 150 to 200 meters wide. When the avalanche was released at about 450 m.a.s.l it ran about 390 meters through sparse forest and trees. It stopped at about 220 m.a.s.l. where the terrain flattened out. The runout was approximately 145 meters wide.

Using observations from the nearby terrain, information from the involved and talking with the rescuers on site, it is highly likely that the avalanche released on a weak layer of facets high in the snowpack.

Figure 7 – Approximate drawn path of the avalanche based on observations. The legend to the left is steepness of the slope.
