Avalanche accident on Erikaksla, Lyngen 30th of March 2022

Accident report

Published 16th of Febuary 2023 on Varsom.no

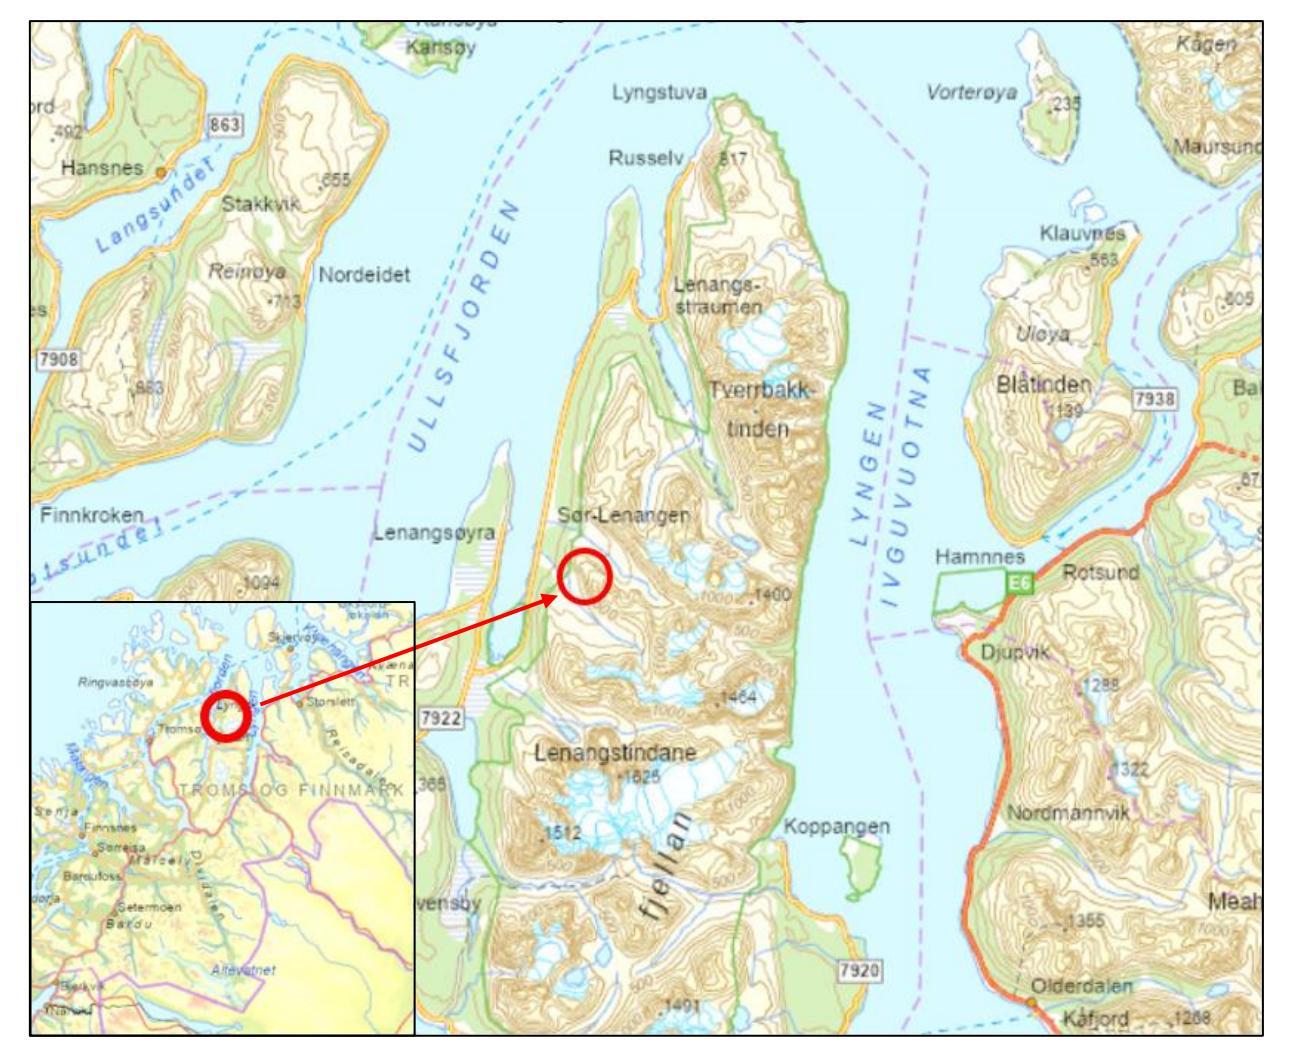
The avalanche was released underneath the ridge of Erikaksla in the northwest part of the Lyngen peninsula. On the southwest side where the avalanche released, the terrain consists of sparse forest.

Figure 6 – Location of the avalanche accident.
